# Manhole Inspection Summary

Manhole # S43II\_007MH

Insp Date: **4/24/08 11:39 AM**

**Location** Address: **Rutland Ave**

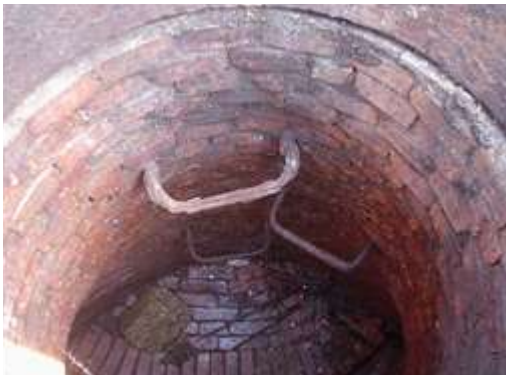
Defect 2

frame leaks

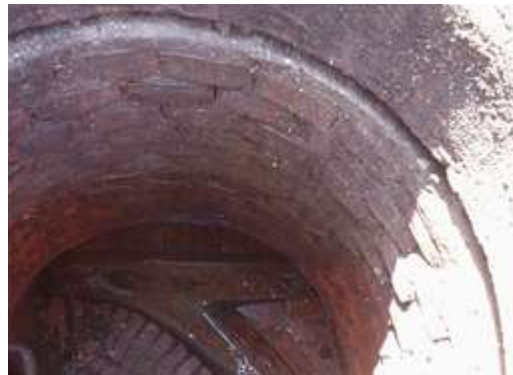
Defect 1

deterioration

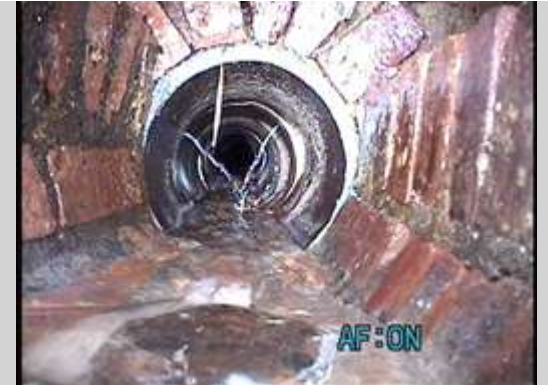
12 O'Clock Outflow

8 in. Circular Gravity Sewer  
Pipe Out @ 12 O'Clock

Pipe Height: **8.4** (in.) Rod and Bar (Angled)  
Pipe Material: **Clay** ☐ Pipe Lined  
Invert Depth: **8.95** (ft.) Flow Characteristics: **Fast**  
Deposits: ☒ None ☐ Mud ☐ Sludge ☐ Debris ☐ Grease  
Silt Depth: (in.) Deposits Extent:  
Infiltration: **None** Pipe Seal Cond: **Sound**

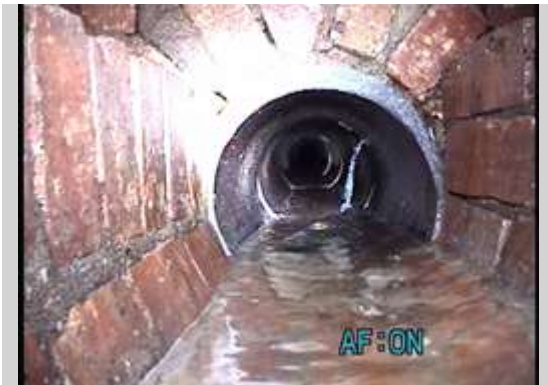
6 O'Clock Inflow

8 in. Circular Gravity Sewer  
Pipe In @ 6 O'Clock

Pipe Height: **8.4** (in.) Rod and Bar (Angled)  
Pipe Material: **Clay** ☐ Pipe Lined  
Invert Depth: **9.00** (ft.) Flow Characteristics: **Fast**  
Deposits: ☒ None ☐ Mud ☐ Sludge ☐ Debris ☐ Grease  
Silt Depth: (in.) Deposits Extent:  
Infiltration: **None** Pipe Seal Cond: **Sound**

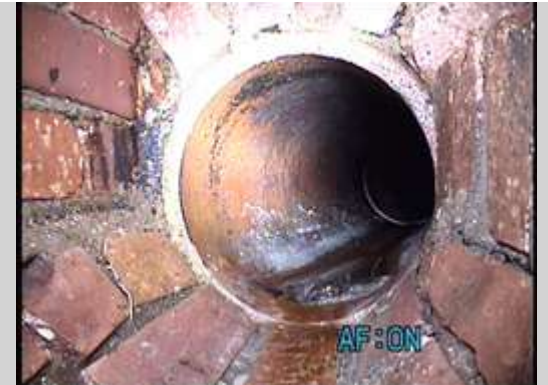
9 O'Clock Inflow

8 in. Circular Gravity Sewer

Pipe In @ 9 O'Clock

Pipe Height: **8.4** (in.) Rod and Bar (Angled)

Infiltration: **None** Pipe Seal Cond: **Sound**
